Solar Energy Materials & Solar Cells

Explanation of potential-induced degradation of the shunting type by Na decoration of stacking faults in Si solar cells

Crystalline Si solar cells that exhibit potential-induced degradation of the shunting type (PID-s) are investigated on a microstructural level. Cell pieces with PID-shunts are imaged by SEM using the EBIC technique in order to investigate PID-s positions with high lateral resolution. ToF-SIMS depth profiles reveal Na accumulation localized at these shunt positions. Subsequently, cross-sectional FIB-lamellas of individual PID-shunts have been prepared. TEM is applied to a number of PID-s defects. TEM/EDX measurements reveal that stacking faults crossing the p–n junction are decorated with Na causing PID-s. These defects are further characterized by high resolution STEM methods down to the atomic scale. A model for the shunting mechanism in PID-s affected solar cells is developed. The results are discussed with respect to different shunting mechanisms.

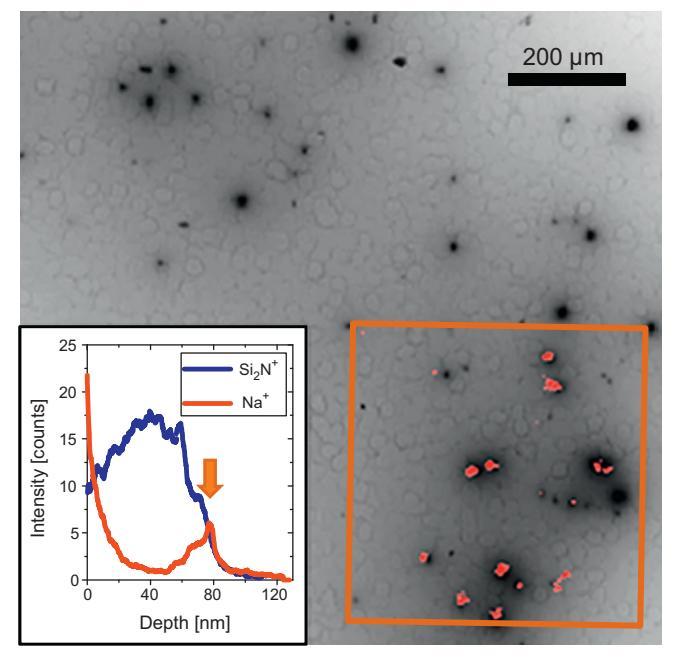
ToF-SIMS data acquired at the same sample region are shown in the framed overlay in the EBIC image in Fig. 1. The red dots within the frame represent the lateral distribution of Na at a depth corresponding to the interface between the SiN_x layer and Si substrate. The spatially resolved Na distribution has been extracted from a 3D depth profile of the Na⁺ signal acquired on an area of $500 \times 500 \,\mu$ m. Obviously Na accumulates at positions which coincide with PID-shunts observed in EBIC imaging. The inset graph in Fig. 1 shows the depth distribution of Na measured at shunt positions. A significant increase of the Na signal (red line) is clearly visible at the SiN_x/Si interface. The interface (see arrow) is indicated by the declining Si₂N⁺ intensity (blue line).

Fig. 1. EBIC image of a monocrystalline cell region with a high density of PIDshunts acquired at an acceleration voltage of 30 kV. The overlay in the EBIC image shows the distribution of Na at the SiN_x/Si interface measured by ToF-SIMS. The graph (inset) shows the depth distribution of Na at shunt sites in comparison with the Si₂N signal being an indicator for the SiN_x/Si interface. (For interpretation of the references to color in this figure caption, the reader is referred to the web version of this article.)

In this model PID-s recovery could be explained as a diffusion driven process. When the outer field across the SiN_x layer is switched off, Na is able to slowly spread back from the stacking fault into the SiO_x interlayer and from that into the SiN_x layer by diffusion and electrostatic repulsion. Broad thermal back-diffusion into the SiN_x layer is delayed due to the low mobility of Na [22], leading to a slow regeneration [24]. Therefore PID-s recovery can be accelerated by means of reverse potential across the SiN_x layer. Dependent on the transport of Na ions back into the SiN_x layer, there is a concentration gradient enabling Na to diffuse out of stacking faults. The Na accumulations measured by ToF-SIMS in the SiN_x/Si interface region (see Fig. 1) are supposed to be the result of beginning out-diffusion of Na.

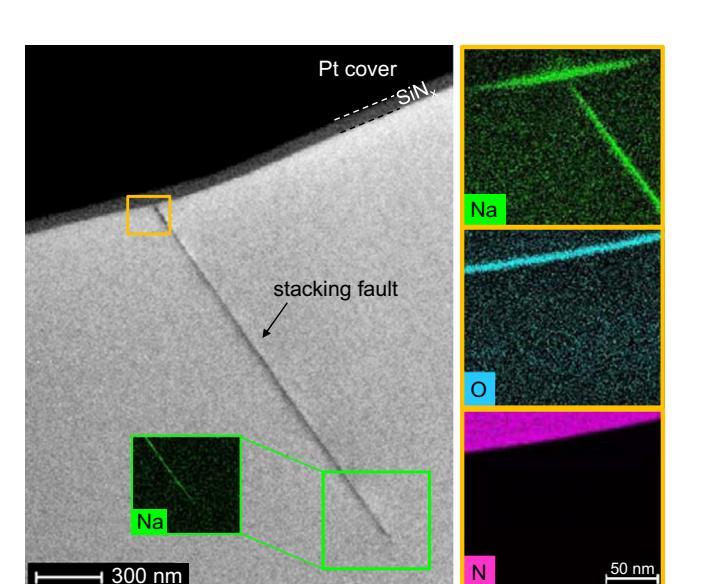
Fig. 2 shows an example of a PID-s stacking fault with its plane oriented perpendicular to the TEM lamella surface and inclined to the surface of the solar cell. The TEM brightfield image in Fig. 2 on the left side gives an overview of the stacking fault. The Pt protection layer, which is needed for the FIB preparation, appears black. Below the Pt layer the \sim 70 nm thick SiN_y layer appears dark grey. Crystalline Si appears light gray in this TEM image. A stacking fault in the Si crystal, reaching from the surface to a depth of nearly 2 µm, is visible as a thin dark line. Elemental composition information is obtained by EDX in scanning TEM (STEM) mode. The corresponding EDX maps on the right hand side show the elemental distribution of Na, O and N near the Si interface. The SiN_x layer is indicated by a high EDX signal for N. An interlayer that contains O is clearly detected in the SiN_x/Si interface region. It is assigned to a thin SiO_x interlayer. From Na-EDX maps it can be derived that Na is located along the stacking fault. Na is observed throughout the stacking fault (not shown here) down to its lower part (inset in TEM image). In addition Na is also detectable in the SiO_x interlayer where the stacking fault touches the interface. Moreover, the Na EDX signal is weakened in the uppermost 50-100 nm of the stacking fault.

A quantitative evaluation of the EDX data for Si and Na yields an estimation for the areal density of 6×10^{14} and 3×10^{14} Na atoms per cm² in the stacking fault plane for depths of (80 ± 40) nm and (1.6 + 0.1) µm, respectively. In comparison, ToF-SIMS also revealed a signal equivalent to an areal density of $\sim 10^{15}$ Na/cm² [10]. Therefore, we assume a density of Na within the stacking fault in an order of magnitude that corresponds to one Si monolayer. It should be noted that a similar Na distribution along the stacking faults has been verified for two other TEM investigations of PID-s affected stacking faults. Other foreign metals than Na have not been detected. In some cases also small amounts of O were found along stacking faults.

Fig. 2. On the left is a brightfield TEM image of a stacking fault affected by PID. The small images on the right represent EDX mappings acquired in STEM mode at this stacking fault near the interface between Si and SiN_y. A Na-EDX map of the lower part of the stacking fault is shown in the inset on the left.

According to our findings that Na is found at stacking faults in cell regions, which have been exposed to PID stress, it is assumed that Na ions drift through the SiN_x layer under the influence of a strong electric field. This is visualized in the upper part of Fig. 7. Na may come from the surface, since contamination with Na is commonly observed on surfaces. Alternatively Na may also be resident within the SiN_x layer as a contaminant. Note that even small volume fractions of Na can lead to high areal concentrations when it is piled up in planes. As shown in Fig. 7, the Na ions are driven towards the SiN_x/Si interface and accumulate in the SiO_x interlayer. Their positive ion charge prevents further Na from drifting to the interface where Na piles up at the Si interface. Pure thermal diffusion of Na in SiN_x is low, while its diffusivity is much higher for SiO₂-like phases [22]. Therefore, Na may easily diffuse laterally inside the thin SiO_x interlayer (see also Fig. 2).

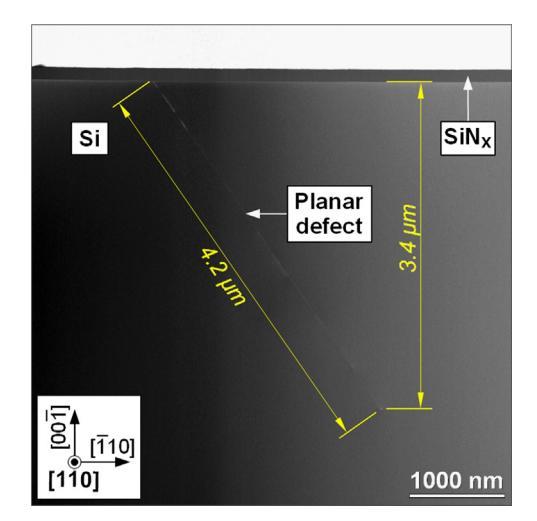
The atomic structure of PID-s stacking faults has been further studied by STEM. An overview of such a PID-s planar defect in cross section ([110] orientation) is shown in the low-angle annular dark-field (LAADF) image in Fig. 3. The LAADF technique is especially useful to image defects by their strain fields. Local atom displacements cause de-channeling of the imaging electrons [11]. The strained regions thus appear bright in comparison to the unstrained regions. In Fig. 3 the stacking fault (which is filled with Na, like the defect shown in Fig. 2) thus appears as a thin, heterogeneously bright line and penetrates the Si from the surface (i.e. the interface between SiN_{r} layer and Si) down to a depth of about 3.4 µm.

The orientation of the defect line with respect to the (001)oriented surface proves that the defect is in a {111} plane. Highresolution annular dark-field STEM is employed to characterize the atomic structure of the planar defect. In the following the crystallographic details are further addressed.

Fig. 3. Low-angle annular dark-field (LAADF) STEM image of a planar defect, which penetrates the Si starting from the interface between Si and SiN_x down to a depth of about 3.4 µm.

Slightly off the defect the $(\overline{1}11)$ -planes are arranged in their typical bulk distance of 0.314 nm. They exhibit a nearly constant high brightness. In the close surrounding of the stacking fault (about 1.5 nm to each side) the brightness maxima of the $(\overline{1}11)$ -planes decrease. The defect stripe itself stands out by the lowest brightness in the image. However, the stripe does not show a continuous contrast but rather a local brightness maximum (see the middle of the profile). As the HAADF contrast is proportional to the mean atomic number in the investigated volume to the power of about 2 [13], the local brightness minimum allows an estimation of the mean atomic number in the middle of the defect to about 6-7. This indicates the incorporation of additional atoms with an atomic number smaller than 14 (the atomic number of Si) as well as of vacancies. In addition, local atomic displacements have to be considered, which also yield a decrease in brightness by de-channeling. That phenomenon is assumed to mainly cause the decrease in the brightness of the Si-dumbbell columns in the surrounding of the defect stripe, because a bright contrast was observed there in the LAADF image (cf. Fig. 3).

The results presented here are not compatible with the electrostatic PID defect model proposed in [7], which assumed that the Na is lying within the SiN_x layer. Our previous TEM investigations (see also Fig. 3) might indicate that the Na atoms are microscopically distributed in the stacking fault not as a completely flat layer but rather quite inhomogeneous. One possibility would be to assume that the Na atoms convert the stacking fault into a thin guasimetallic layer, which could explain the ohmic conductivity across the p-n junction. Then the defect would act like the model for type-2 breakdown mechanism proposed in [25]. However, one may also assume that, within the p-type bulk material, the defect acts as a Schottky diode instead of an ohmic contact. On the other hand, a well-rectifying Schottky diode is only expected for an ideal metalsemiconductor contact. This Na-Si contact, however, can be expected to be highly disturbed and may be contains a Cottrell atmosphere of point defect levels around, which may convert it to an ohmic contact to the bulk, as it is observed here.

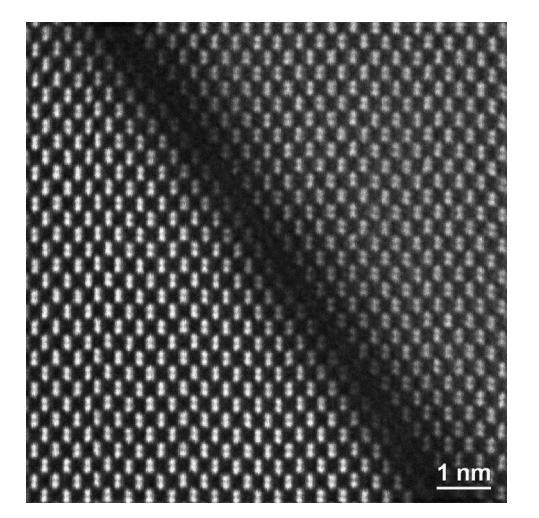
The high-angle annular dark-field (HAADF) image in Fig. 4 illustrates the atomic structure of a typical $9 \text{ nm} \times 9 \text{ nm}$ cutout from the defect. In the diagonal of the image a dark stripe is distinctly noticeable lying parallel to the $(\overline{1}11)$ atomic planes of the Si crystal, which indicates a stacking fault. However, a clean intrinsic stacking fault should be characterized by a single layer of rotated dumbbells and in an extrinsic stacking fault there should be two rotated dumbbell layers [12]. In contrast to a clean stacking fault, the atom dumbbells, being directly adjacent to the dark stripe in Fig. 4, appear darker than the Si dumbbells in the bulk. Furthermore, they have the same orientation as the bulk dumbbells which is parallel to $[00\overline{1}]$ in the projection onto the paper plane. This phenomenon demonstrates a structural modification of the original stacking fault by the potential-induced degradation process, which yields the Na agglomeration at the fault plane as already described (cf. Fig. 2) and also proven by EDX at the defect under discussion. The arrangement of Na atoms within the fault thus appears to induce moving of Si-atoms in the neighborhood, which finally reorients the Si dumbbells in the projection. However, directly next to the dark stripe there are also dumbbells with an orientation as in the original stacking fault, which will be shown in Fig. 6.

Fig. 4. HAADF image showing the atomic structure of a PID-s fault.

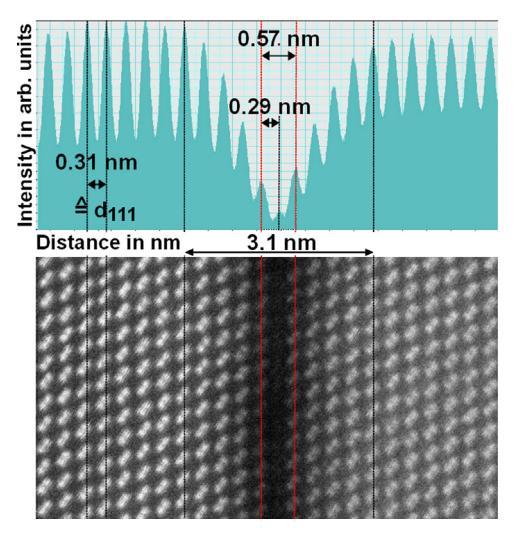
The dimensions of the defect as well as its HAADF contrast are considered in detail in Fig. 5, which shows an unprocessed cutout of Fig. 4. The image has been rotated to align the $(\overline{1}11)$ atomic planes

Fig. 5. Dimensions of a PID-s affected stacking fault determined by a brightness profile (top). The corresponding HAADF image with the defect in the middle (bottom) is an unprocessed cutout of the HAADF image in Fig. 4.

to the vertical image edges. Above the image the corresponding brightness profile is shown. The brightness is averaged over the height of the cutout and is plotted against the cutout width.

The distance of the adjacent Si dumbbells on both sides of the investigated fault is 0.57 nm. This distance is distinctly smaller than

that of the Si dumbbells adjacent to an extrinsic stacking fault, which is characterized by a double fault layer. The observed distance is rather in the range of an intrinsic stacking fault (being characterized by a single fault layer) [12]. Thus, assuming an intrinsic stacking fault, the measured stripe width of 0.57 nm corresponds to a widening of the original stacking fault by about 0.25 nm. This supports the thesis that Na atoms aggregate in the original fault plane. The fact that the Na atoms have not been imaged as bright spots by HAADF might be attributed to an irregular incorporation of Na, i.e. the positions of Na atoms might differ along the thickness of the lamella. Moreover, a lower density of atoms compared to the bulk Si has to be taken into account. The incorporation of Na in the fault plane appears to locally induce a re-arrangement of Si atoms at the fault as shown in Fig. 6a and b. It may be speculated that at the fault the Na atoms form locally arrangements comparable to that in the Zintl phase NaSi. In the lower part of Fig. 6b Si dumbbells can be seen adjacent to the stacking fault maintaining the original fault orientation. In contrast, dumbbells in the same plane turn towards the bulk orientation in the upper part of Fig. 6b. That might have been induced by an arrangement of Na above the dumbbells forming triangle units as marked in Fig. 6b. In Fig. 6a all Si dumbbells are realigned in the bulk orientation which is consistent with an annihilation of the fault.

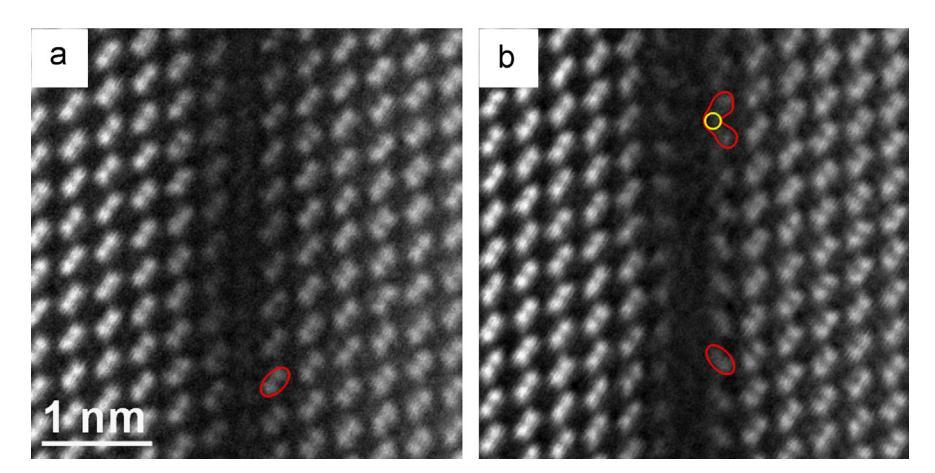
The width of an intrinsic stacking fault is about 0.32 nm, whereas a stacking fault of the extrinsic type measures about 0.63 nm [14,15]. Although Na is incorporated into the PID-s defect, its width of 0.57 nm is smaller than that of an extrinsic stacking fault. Thus, the original defect is supposed to be an intrinsic stacking fault before the degradation. In addition to the widening of the original stacking faults, the defects seem to be structurally modified as a consequence of the PID process. The arrangement of Na atoms within the fault seems to induce a shift of Si-atoms in the neighborhood, which finally reorients the Si dumbbells in the projection.

Fig. 6. Re-arrangement of Si atoms in the dumbbells being located adjacent to the fault. In (a) all Si dumbbells are realigned in the bulk orientation. In (b) the dumbbell rotation of the original stacking fault is locally maintained (marked by the lower red oval). Above, Si atoms also seem to shift by arrangement of Na nearby (yellow), thus forming triangle units. (For interpretation of the references to color in this figure caption, the reader is referred to the web version of this article.)

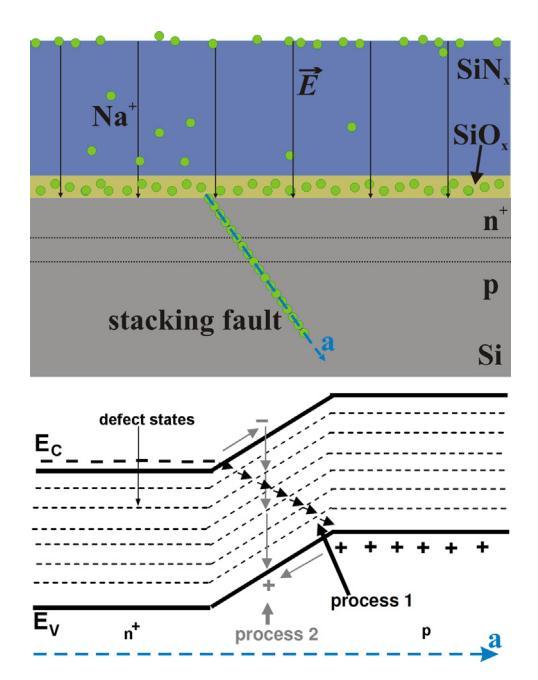
Fig. 7. Schematic drawing of a solar cell cross section. An electric field across the SiN_x layer causes drift of Na^+ ions towards the Si interface. Na scatters in a thin interfacial SiO_x layer. Diffusion into stacking faults takes place. The lower drawing shows the proposed band structure along a decorated stacking fault. The current flow across a PID-s defect is shown at high level concentration (process 1, black) and at relatively low local level concentration (process 2, gray).

Stacking faults provide two-dimensional diffusion channels. In contrast, thermal diffusion of Na in Si bulk is low at room temperature [23]. Na is supposed to enter stacking faults from the SiO_x interlayer and then becomes neutralized by free electrons in the emitter. This neutralization allows further Na to follow through the SiN_x layer towards the Si interface. A decoration of the stacking fault by Na is supposed to create a shunt across the p–n junction (see 'Shunting mechanism').

At relatively low level concentrations we may already see interlevel recombination via levels of different energies located at the same place in the middle of the depletion region ("process 2", gray in Fig. 7). Here, the lateral overlap of neighboring defect orbitals is still too low to enable significant lateral hopping conduction. Then this defect leads to depletion region (2nd diode) recombination with a large ideality factor, as it has been described theoretically in [28] and has been found experimentally on PID-affected cells in [24]. Since this process needs thermal activation, it leads to a non-linear *I*–*V* characteristic.
